CALSPAN ON-SITE AIR BAG DEPLOYMENT INVESTIGATION

CALSPAN CASE NO. 95-20

**VEHICLE #1 - 1994 CHEVROLET CAMARO Z28 CONVERTIBLE
(DUAL AIR BAG-EQUIPPED)
LOCATION - UTAH
CRASH DATE - [REDACTED] 1995**

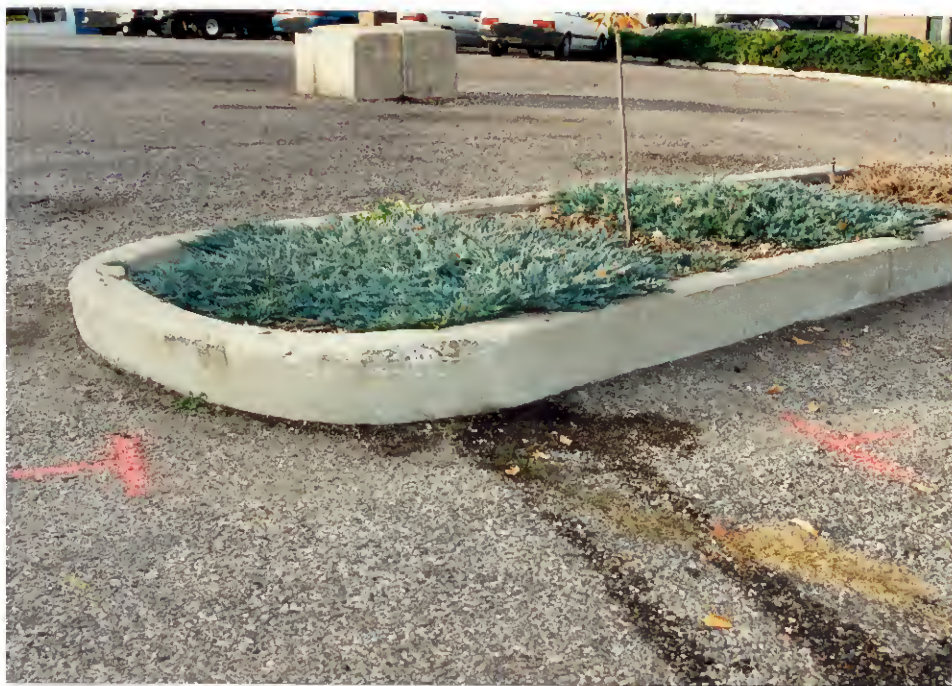
The rack and pinion housing immediately to the left of the skid plate and extending to the left 13.0 cm (5.1") also contacted the concrete curb. This contact fractured the housing and displaced the left side of the steering rack 3.8 cm (1.5") upward and rearward. Power steering fluid was released through the fracture site and was visible on the asphalt at the scene (refer to photographs #13-#14 on page A-7, #53 on page A-27).

14. Closer view of the POI. Leakage of power steering fluid from Vehicle #1's fractured rack and pinion housing can be seen by the darkened asphalt surface at the base of the curb.

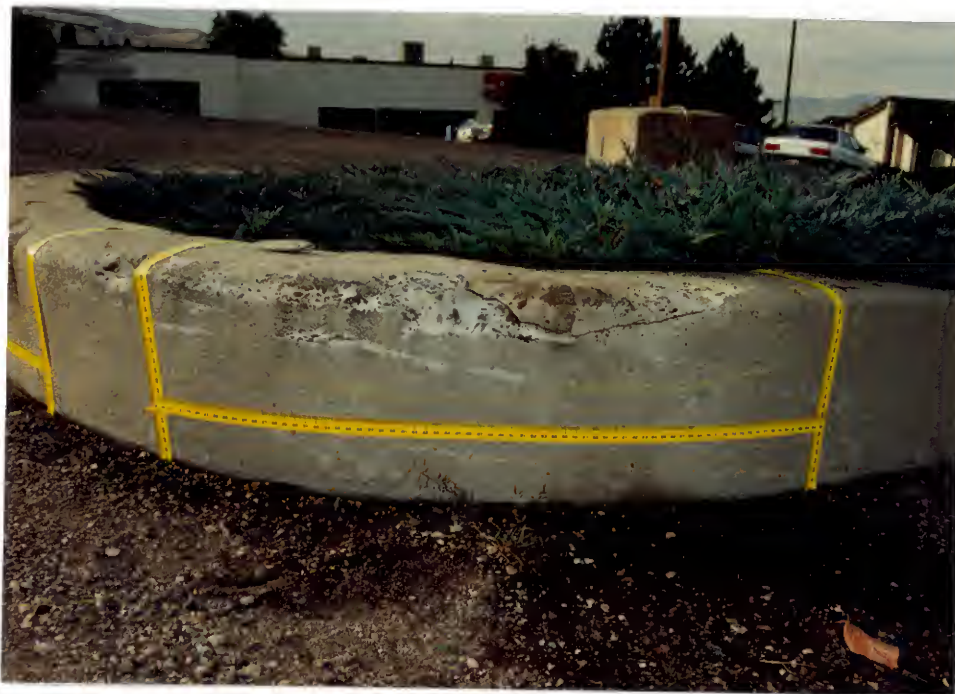
15. Close-up view of the curb showing contact by Vehicle #1's undercarriage.

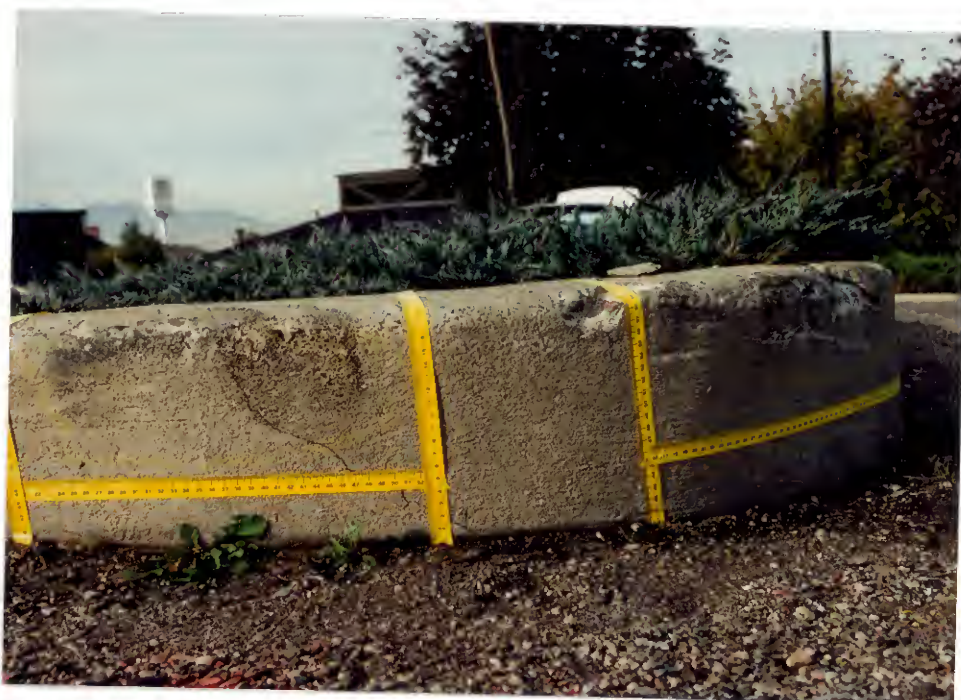
16. Close-up view of the curb showing contact by Vehicle #1's left front tire.

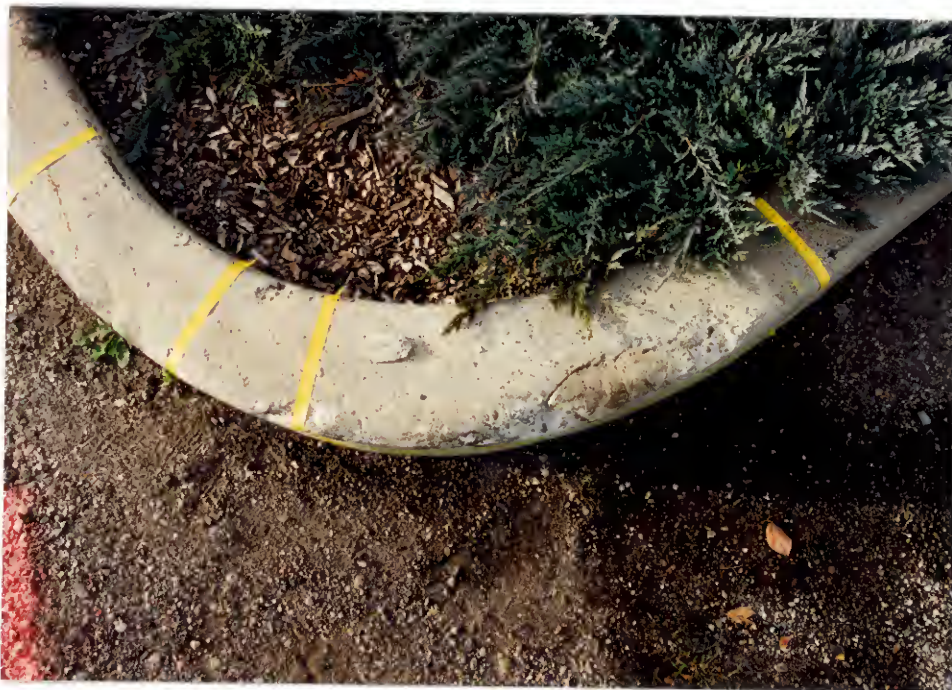
17. Overhead view of the POI showing the undercarriage contact pattern and the left front tire contact.

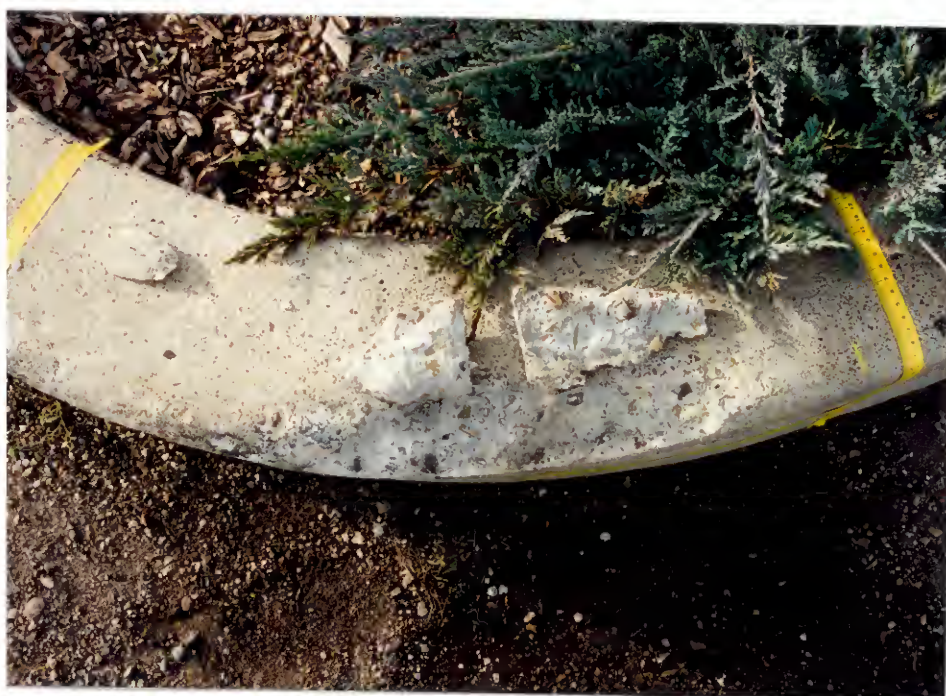
18. Overhead close-up view of the undercarriage contact with the curb showing concrete fragments separated during the crash.

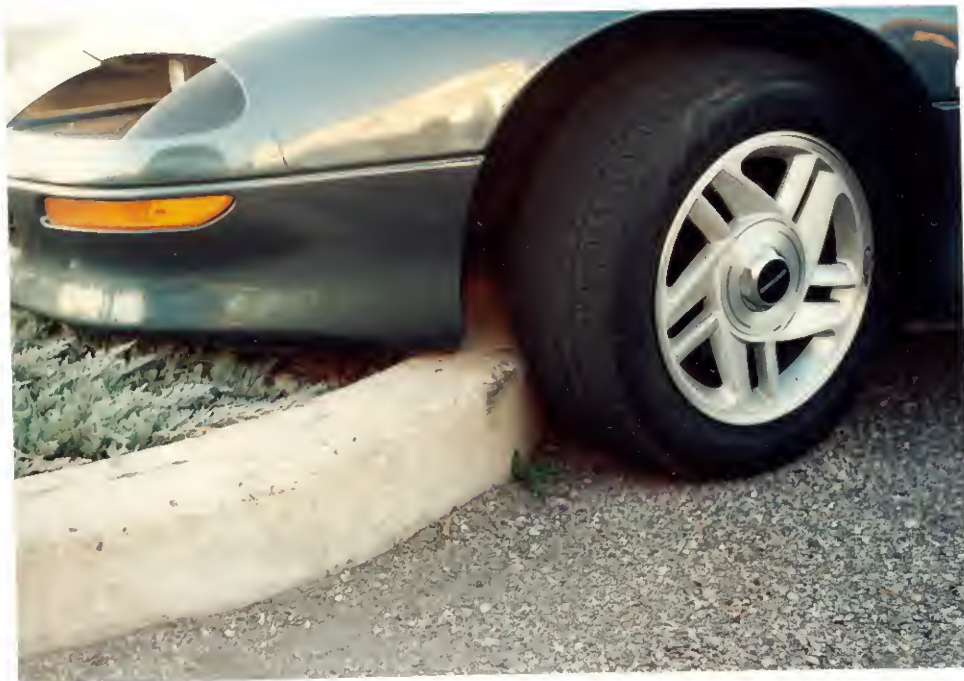
The engine cradle was displaced rearward 12.7 mm (0.5") as the result of the contact sequence. The left front tire contacted the curb as noted in the scene photographs and subsequently rebounded slightly as noted in on-scene photograph #22 on page A-11.

22. On-scene police close-up photograph of the left front corner of Vehicle #1 at the FRP.

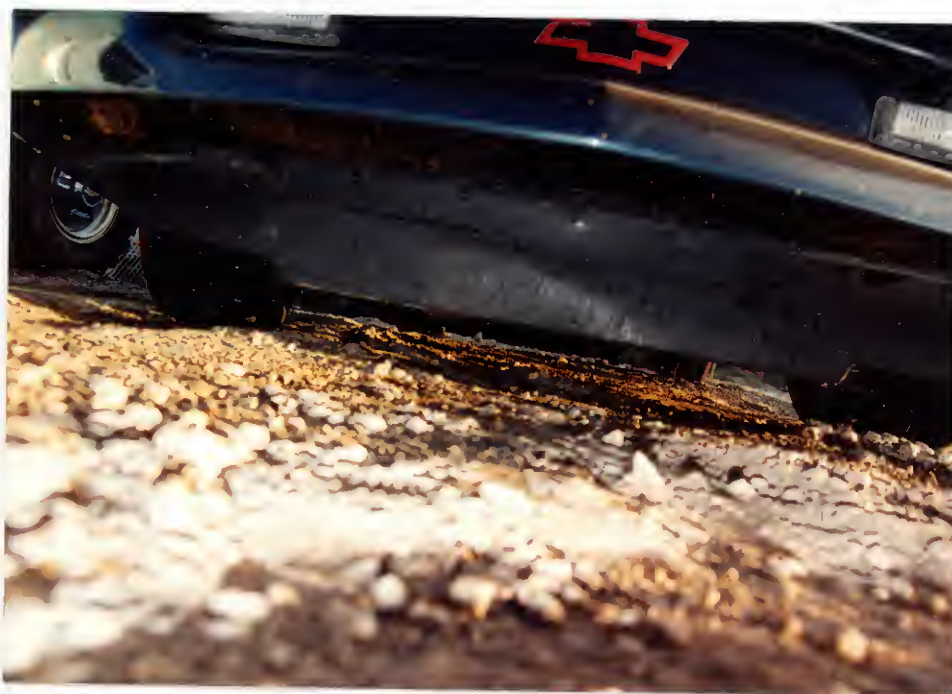
47. View of the front air dam showing curb impact gouges .

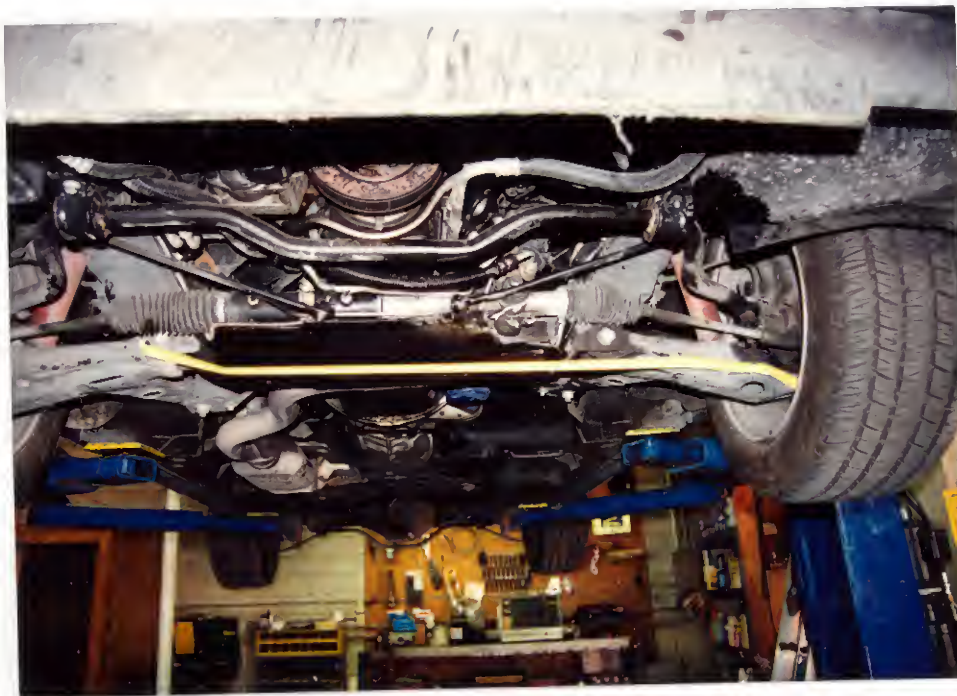
The second undercarriage contact point involved the front anti-sway bar. Due to the stiffness of this component and the observed concrete residue noted on the bar (refer to photographs #49, #50 on page A-25), it was hypothesized the magnitude of this contact was sufficient to decelerate the vehicle and close the arming sensor.

49. Overall view of undercarriage components. The primary areas of interest include the front air dam at the top of the photograph, the front anti-sway bar, the leading edge of the engine frame cross member (i.e., skid plate), and the rack and pinion power steering housing.

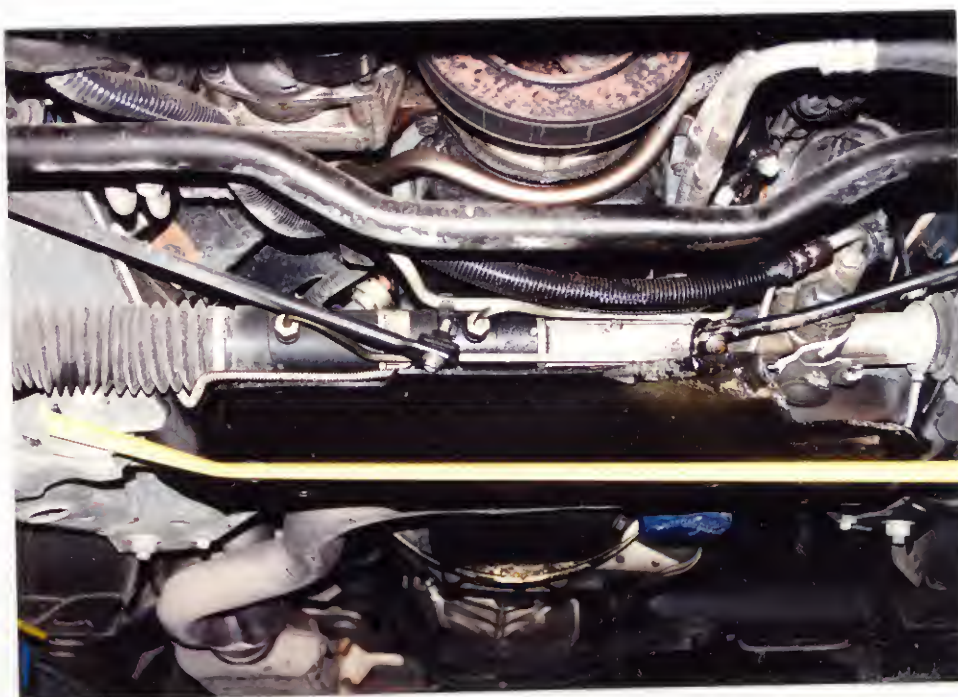
50. Closer view of the front anti-sway bar, the skid plate, and the rack and pinion power steering housing.

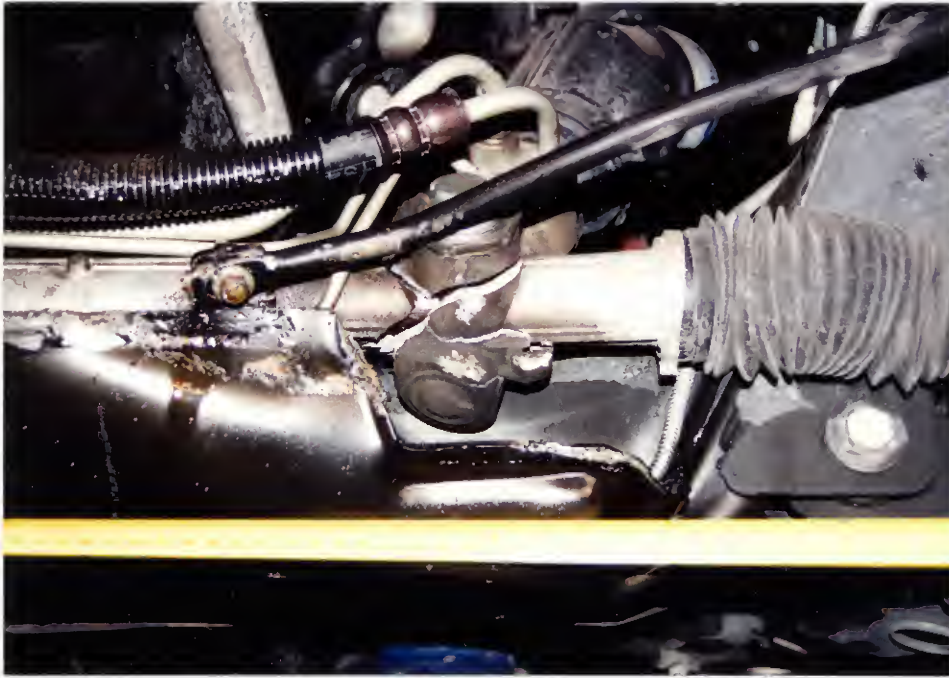
53. Close-up view of the skid plate deformation and the fractured rack and pinion housing.

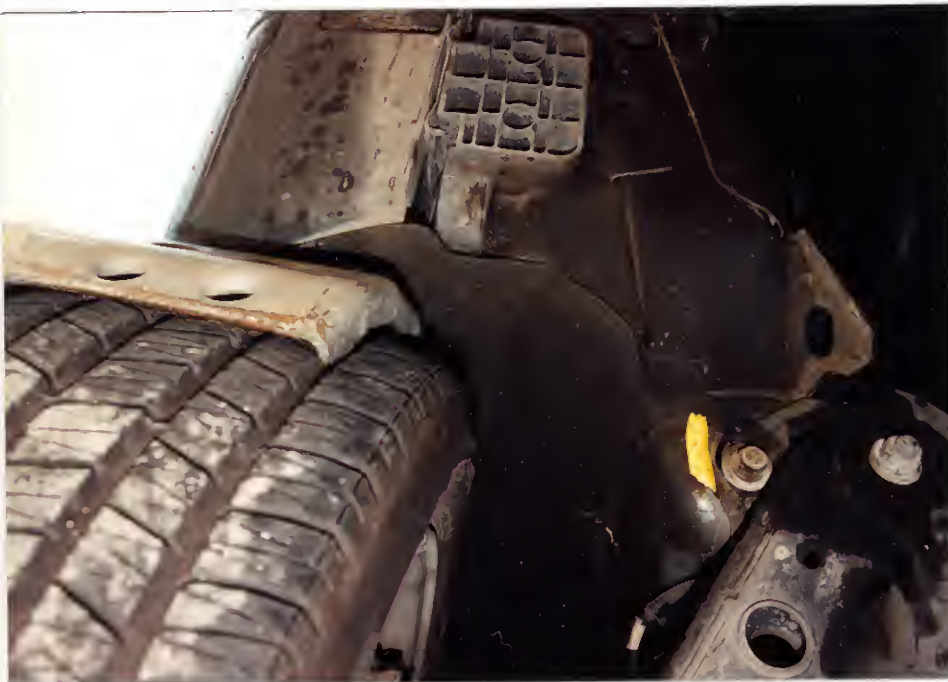
54. View of the 12.7 mm (0.5") rearward movement of the engine cradle as measured at the left rear engine cradle bolt.

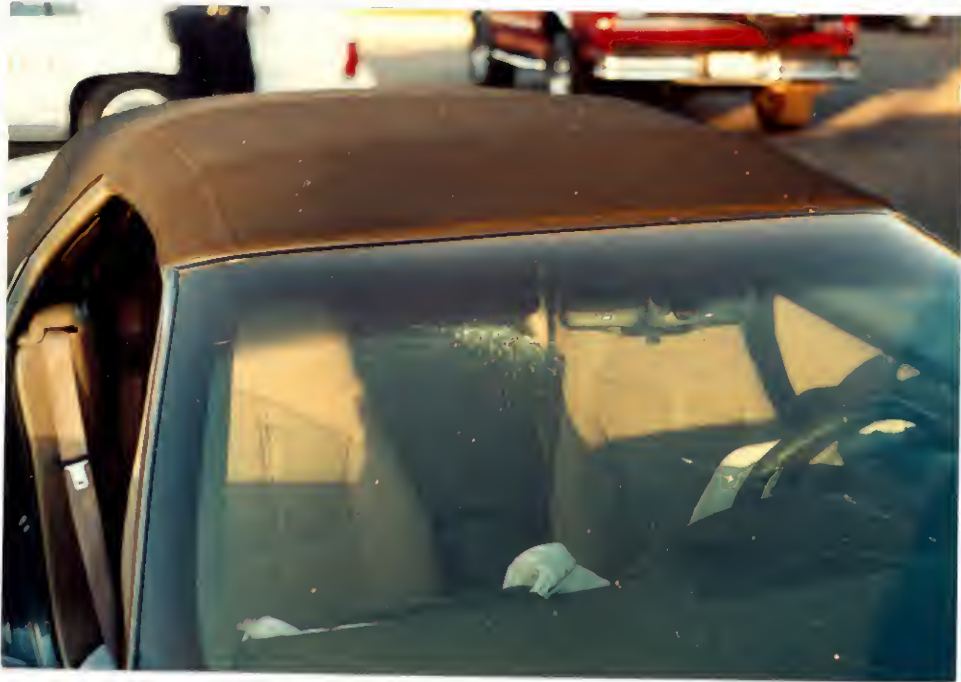
65. Police on-scene photograph of Vehicle #1 showing the crack in the windshield which resulted from contact by the air bag module cover.

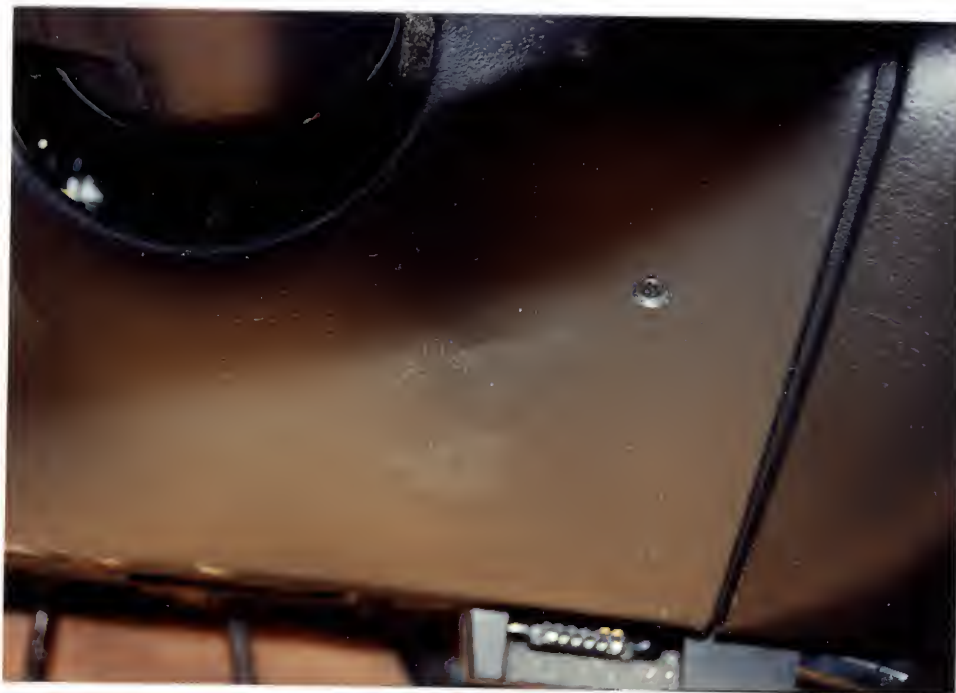
75. Contact evidence on the right side of the driver side knee bolster.

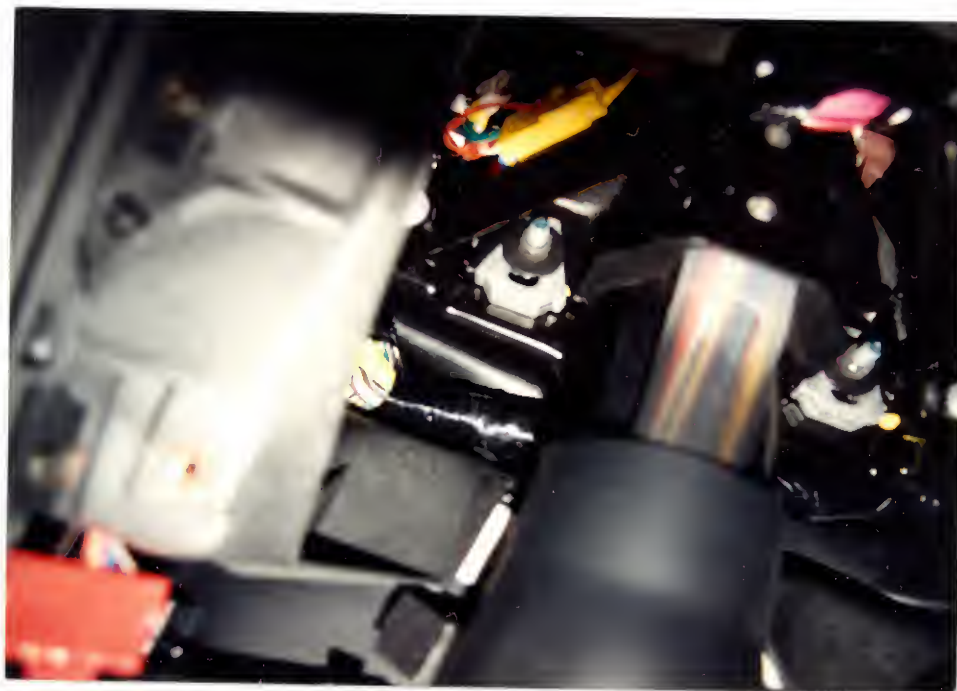
The steering wheel rim was not damaged and the steering column shear capsules were not displaced. The front wheels did not respond to steering wheel turning input applied during the post crash vehicle damage evaluation. Damage to the rack and pinion allowed the turning of the steering wheel, but the steering linkage reacted independently. The position of the steering wheel rim at the final rest position (FRP) was rotated approximately 180° as seen in on-scene police photographs.

76. View of the steering column shear plate and capsules which shows no movement from occupant loading.

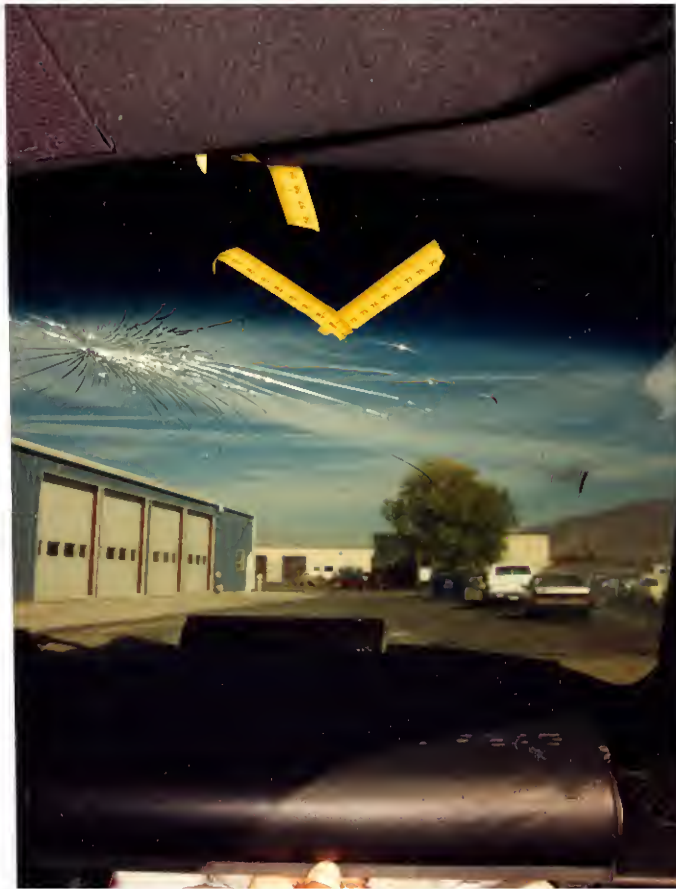
The passenger side air bag module flap separated along the predesigned tear points and contacted the windshield with the left side causing a spider web crack pattern (refer to photographs #83, #84, #87 on pages A-42, A-44). The right side of the cover also contacted the windshield resulting in a black transfer mark adjacent to the right upper A-pillar.

83. View of contacts by the right front occupant on the windshield and windshield header which were noted by yellow calibrated tape.

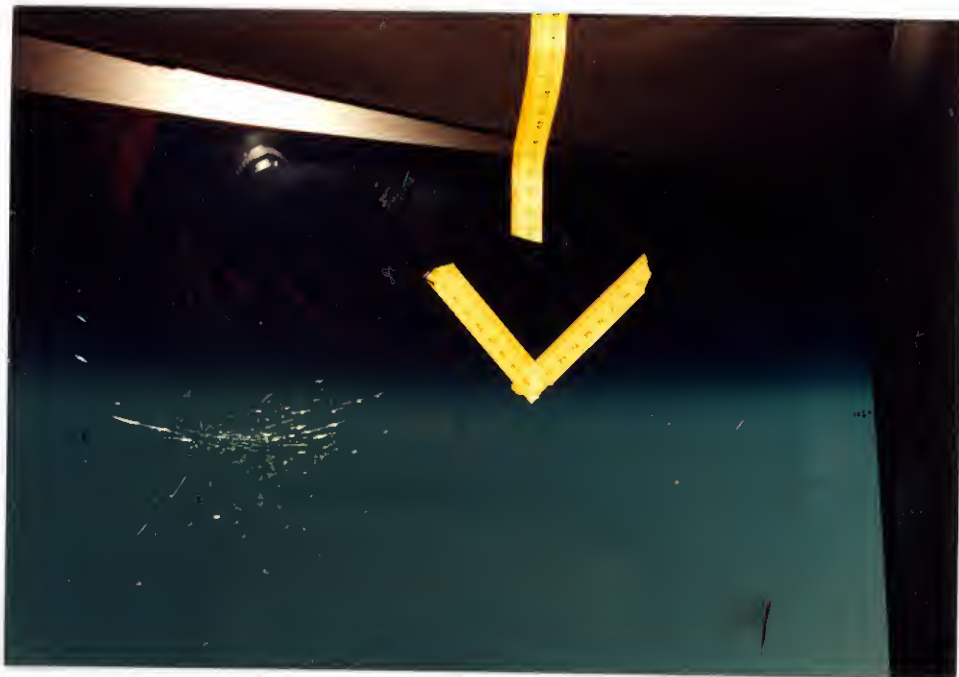
84. Closer view of the windshield and windshield header contact points. The star pattern in the windshield and dark transfer mark near the A-pillar on the windshield were the result of contact by the passenger side air bag module cover during the deployment sequence.

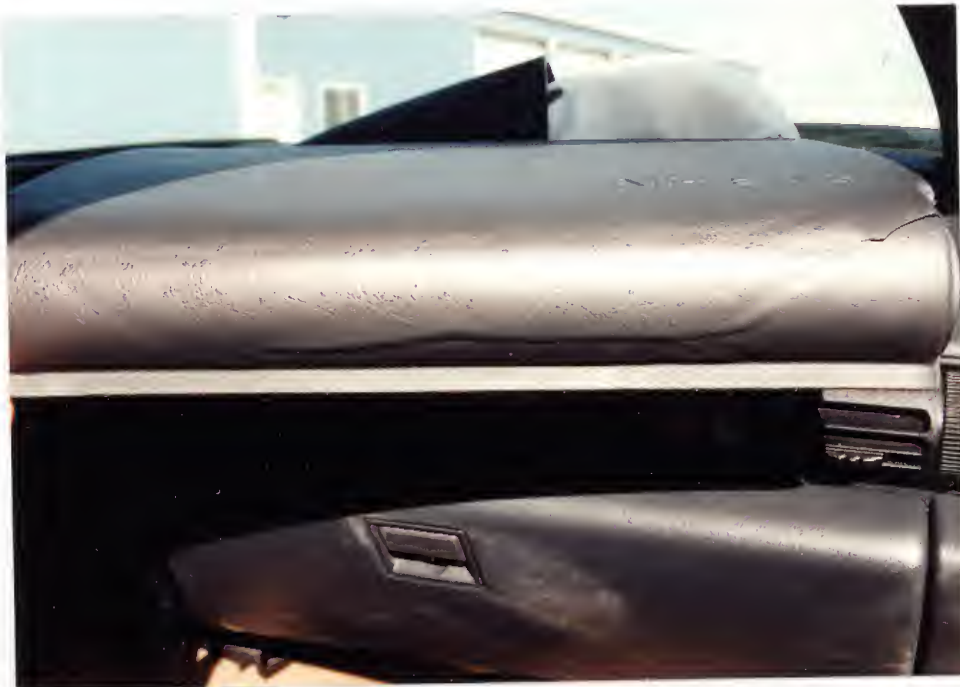
The leading edge of the passenger side air bag module flap along a lateral area measuring 19.1 cm (7.5") was deformed (refer to photograph #88, #89 on pages A-44, A-45) as the result of contact with the right front occupant's head/face. The right corner of the cover exhibited a crack which extended from the right edge inward 2.8 cm (1.1").

88. Close-up view of the leading edge of the passenger side air bag module cover.

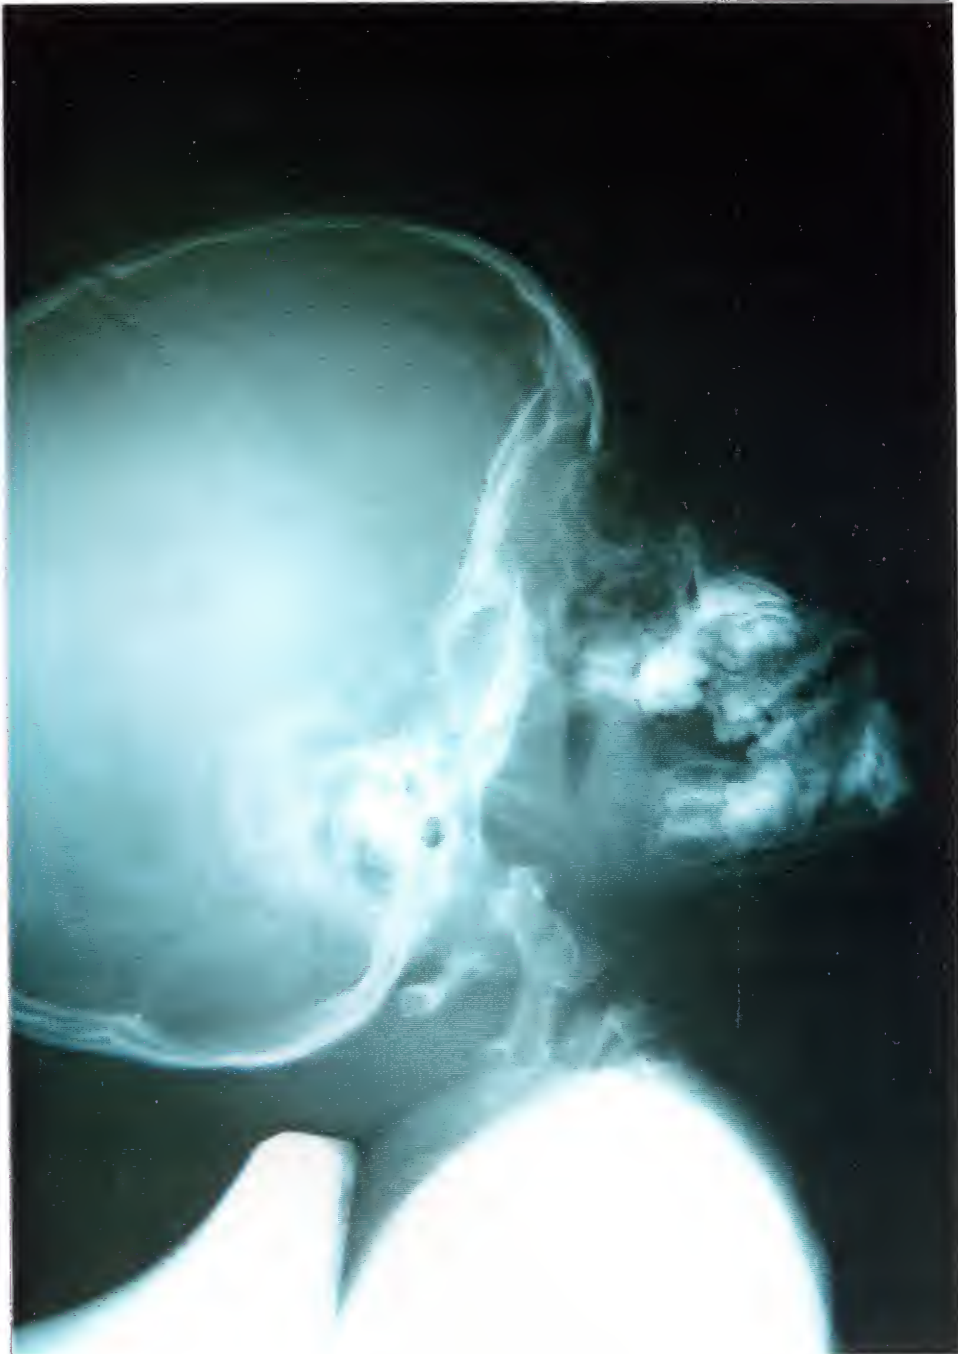
115. X-ray view taken from the right side of the cervical vertebrae with the neck in the extension position.
Note the rearward position of the odontoid bone into the spinal canal.
